Briefing Notes 3-29-07

## Preliminary Analytical Results: 03/29/2007 Well water sampling - Enterprise Recovery Systems (ERS) Site, Byhalia MS February 12-16, 2007

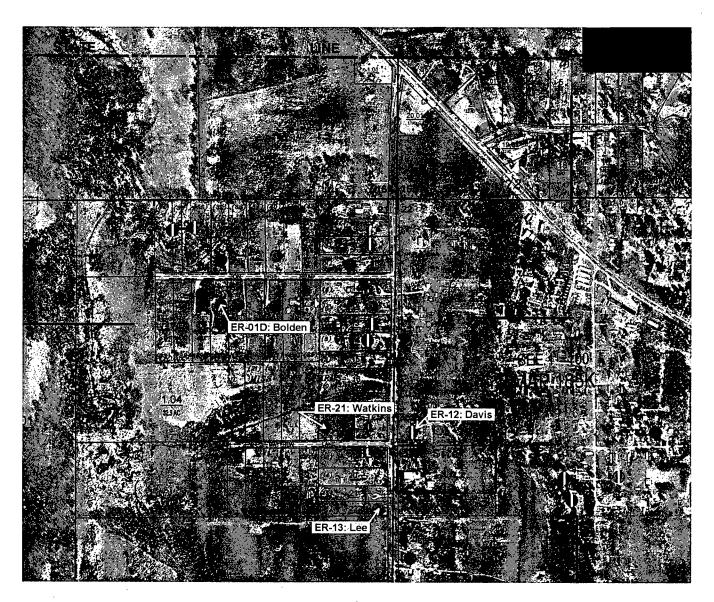
Figure 1 (next page) shows the locations of the four wells with detections, as well as all wells sampled.

FIGURE 1. Wells sampled in red; stripe means DW source. Groundwater flow direction is to the upper left (NW).
